**STS-114  
PROGRAM FLIGHT  
READINESS REVIEW**

**ORBITER  
PROJECT (MV)**

**JUNE 29, 2005**

# **STS-114 PROGRAM FLIGHT READINESS REVIEW**

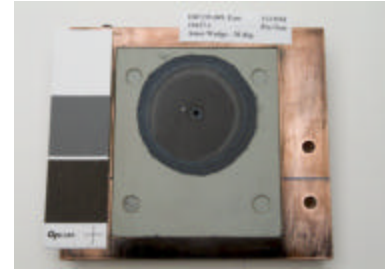
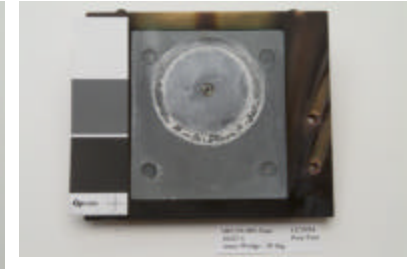
*Pre-test*

*Post-test*

**0.057" thick flexible CSiC cover plate coated with MCM 700 and NOAX edge seal (0.020" edge gap)**

- STS-114 RCC projected repair capabilities are based on developmental testing performed to date
  - Human Thermal Vacuum
  - Arc-jet
  - Glove box
  - Cover plate fit check
  - Vibration test
- Plug Repair Capabilities
  - 12 plug cover plates covering ~65% of total WLESS RCC surface (3" diameter hole)
    - Successfully passed simulated re-entry environment in arc-jet test facilities
    - Successfully validated cover plate mapping
    - Successfully passed vibration test with engineering proto-type
  - One of the initial 13 cover plate might not be usable due to internal flaw (void)
  - Each plug cover plate can repair up to a 4" diameter hole with 1" surrounding spalled coating

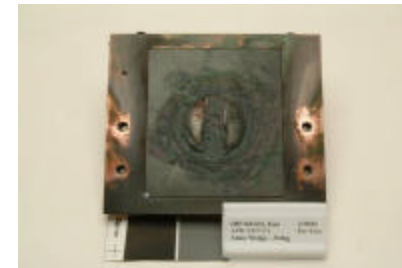
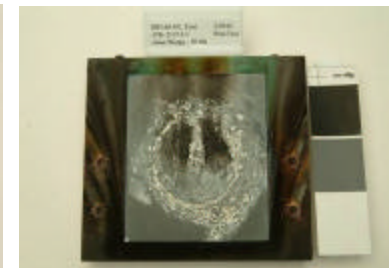
*Pre-test*

*Post-test*

**Flexible CSiC plug coated with MCM 700 and NOAX edge seal with Velcro and RTV-566 (0.037" edge gap)**

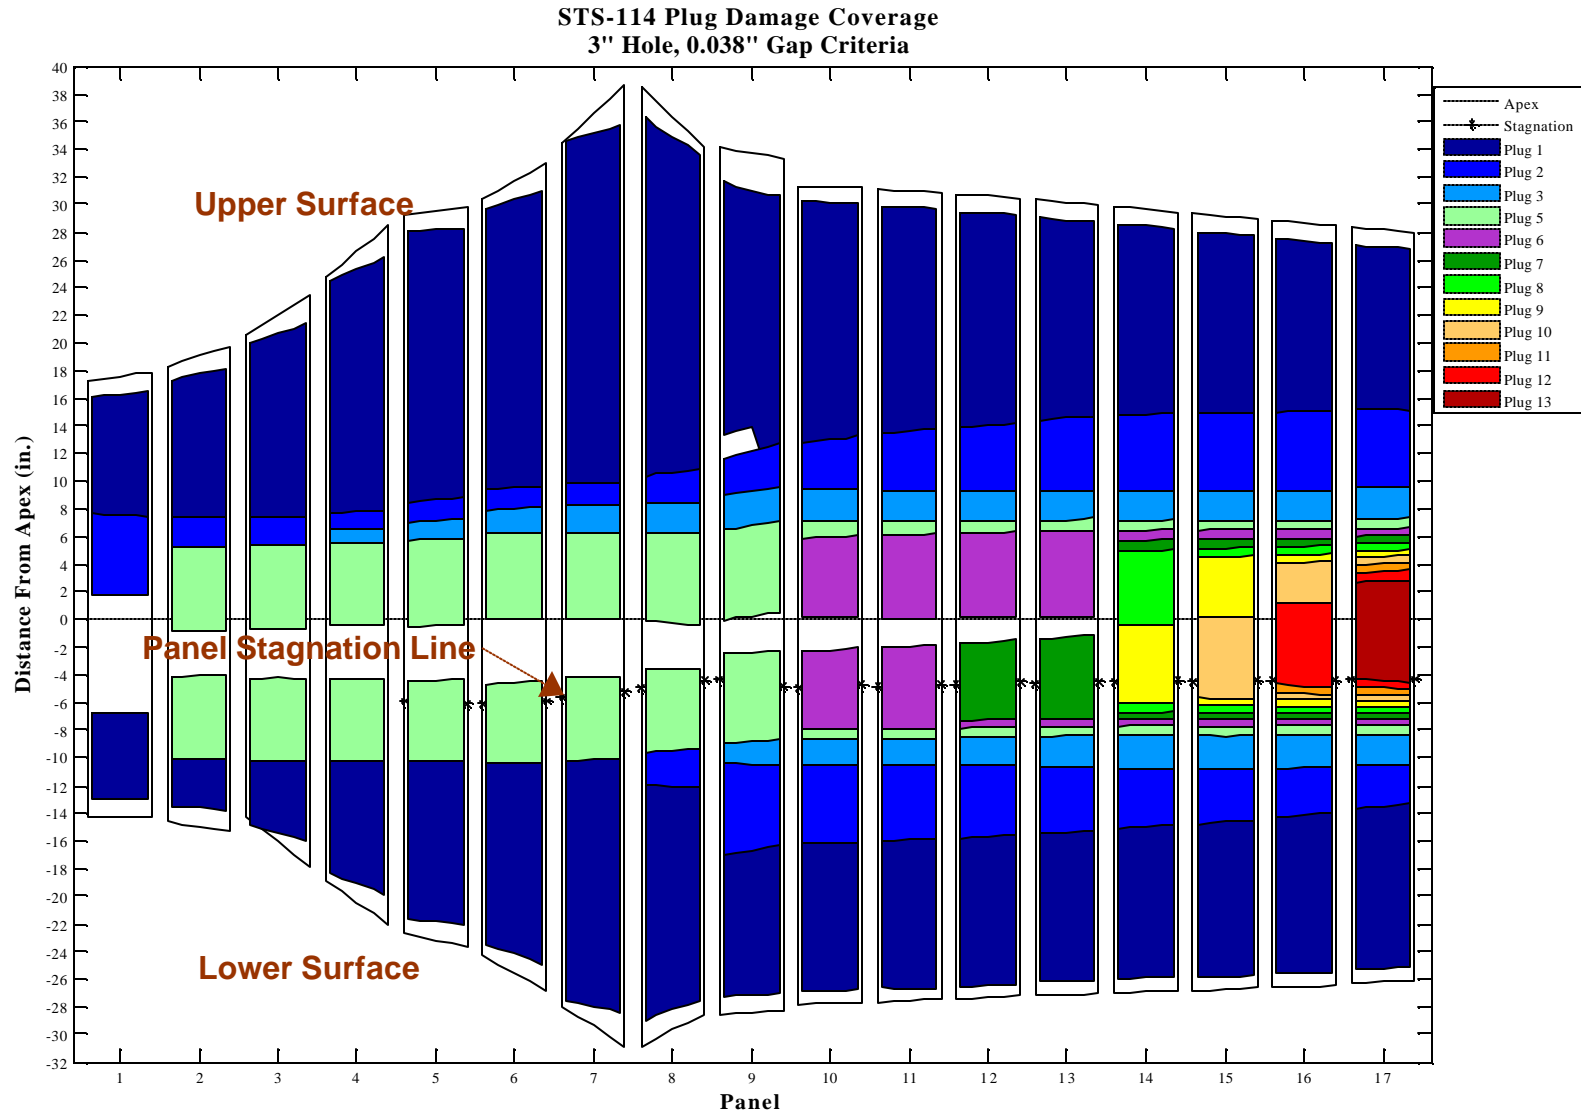
# STS-114 Plug Cover Plate Coverage

\* Panel width shown is not to scale

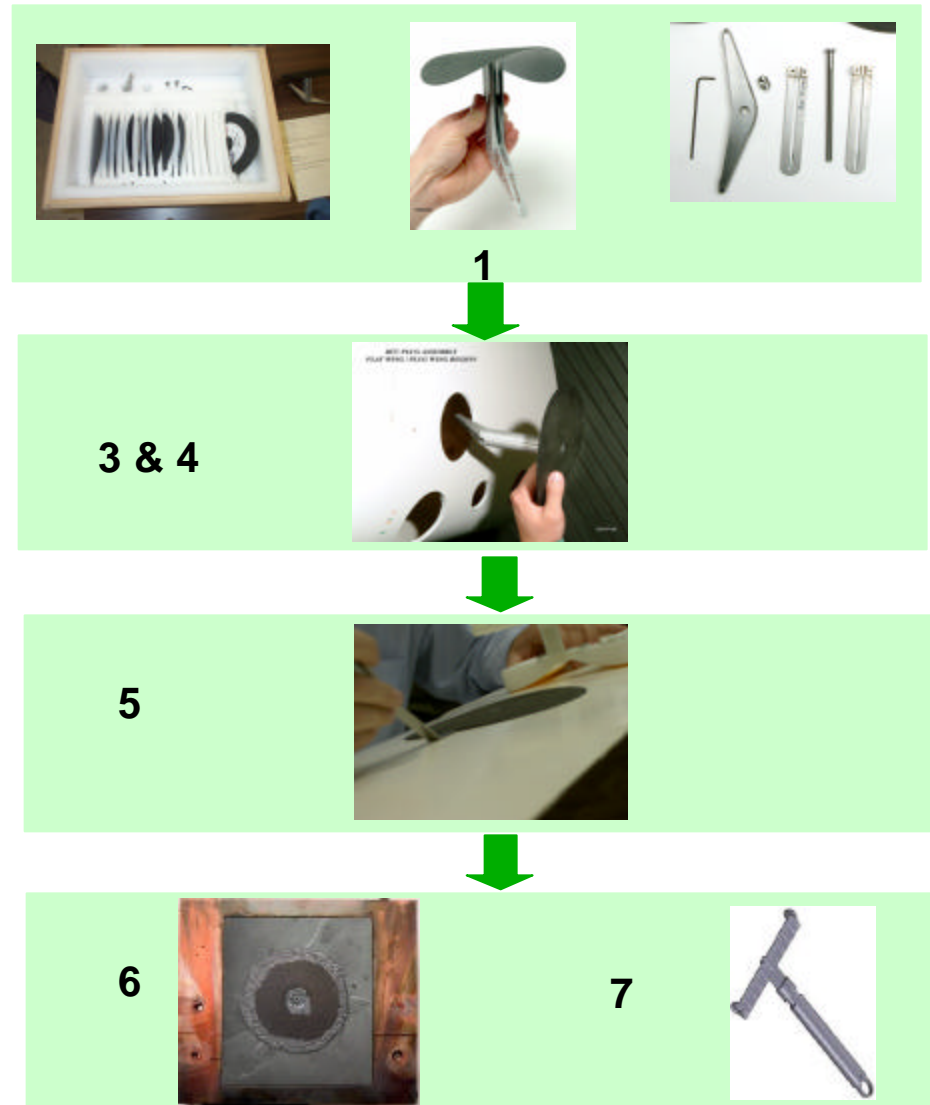
- Retrieve and assemble Plug cover plates and attachment hardware
  - Cover plates to be retrieved will be determined real time
  - Three Plug assemblies will be carried out to the damage site
- Retrieve Plug repair EVA tools
- Translate to repair site
- Install Plug assembly at the repair site
- Measure and verify cover plate edge gap
- Apply edge sealant
- Verify final repair protuberance

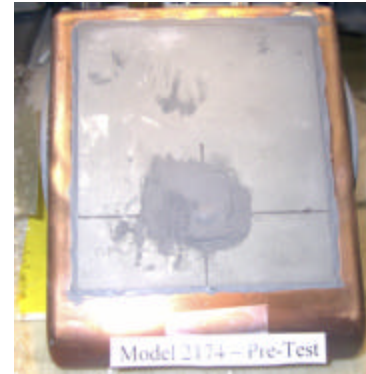
**Pre-test**

**0.5" dia. X 0.12" D Gouge in RCC repaired with NOAX**

- STS-114 RCC projected repair capabilities are based on developmental testing performed to date
  - Human Thermal Vacuum
  - Arc-jet
  - Glove box
- Crack Repair Capabilities
  - Crack repair can be performed at all accessible RCC surfaces
  - Uncured NOAX successfully passed simulated re-entry environment in arc-jet test facilities
    - Approximately 10 to 15 minutes of working life when applied to substrate temperatures between 50° – 100° F

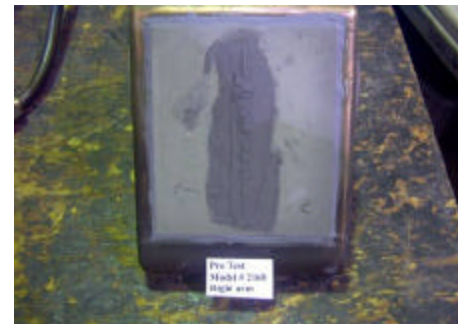
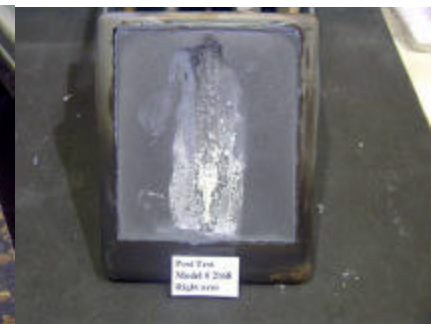
**Pre-test**

**Post-test**

**0.0625" W X 4" L crack repaired with NOAX**

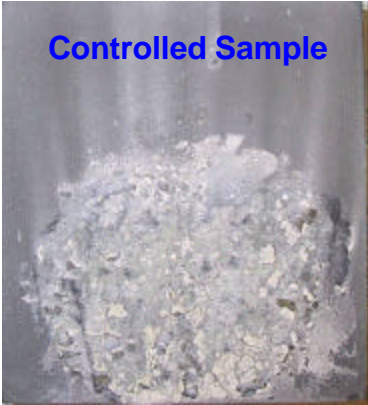
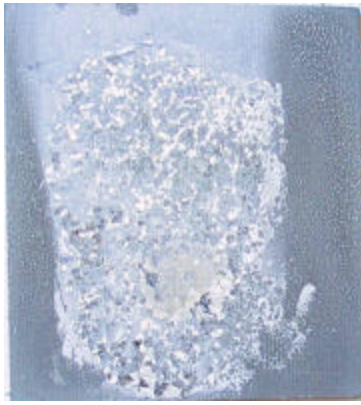
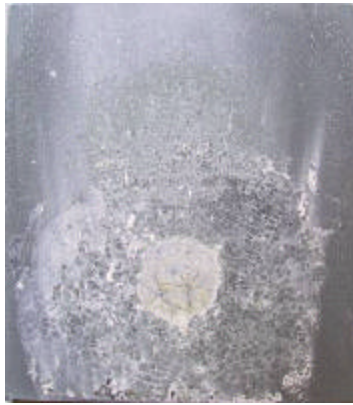
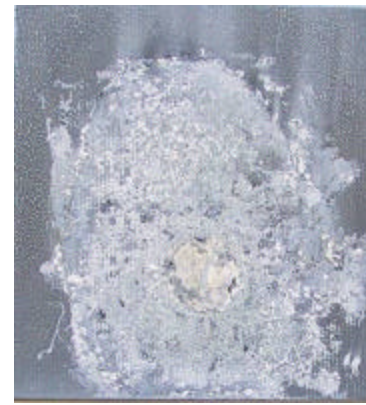
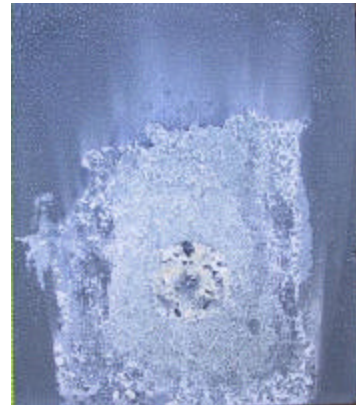
# Uncured Feasibility - Wedge

Controlled Sample

Vacuum Cured/ 300°F for 30 min.

Vacuum Cured/ 7 days  
Hot Cycle

Vacuum Cured/ 2 days  
Hot Cycle

Vacuum Cured/ 7 days  
Cold Cycle

Vacuum Cured/ 2 days  
Cold Cycle

+cure

- Thermal/Aerothermal: Arc-jet confidence tests
    - Wedge tests (2960 deg F)
      - 0.020" and 0.0625" wide cracks, 4" long (cured)
      - 2" diameter gouges; 0.12" deep (cured)

- 1" OML and 2" IML spalled coating (uncured)
    - Stagnation tests (2960 deg F)
      - 0.035" X 1.5" L crack (cured)
      - 1" OML and 2" IML spalled coating (uncured)

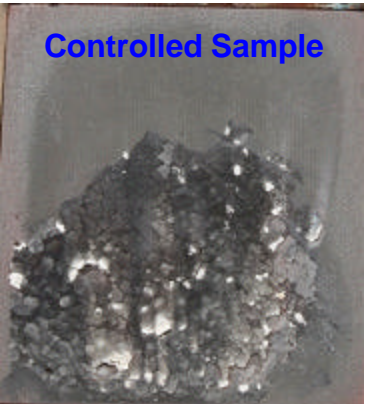
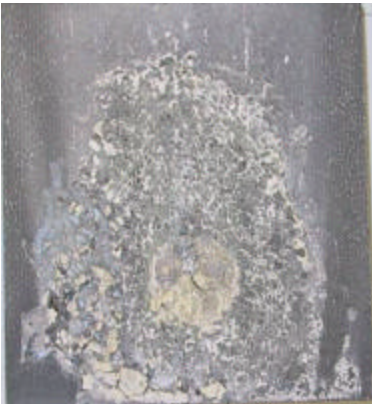
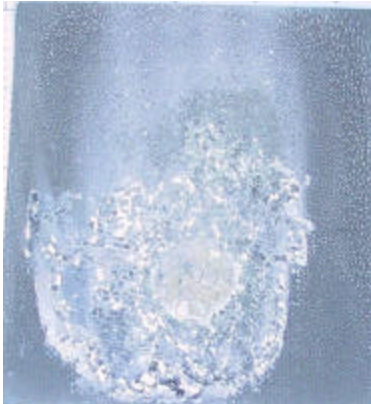
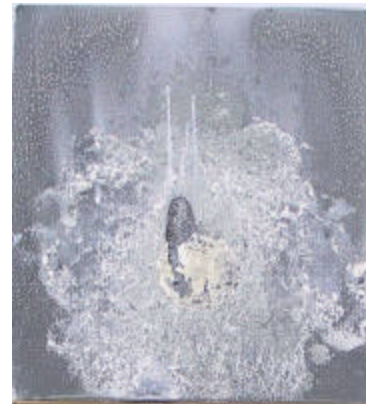
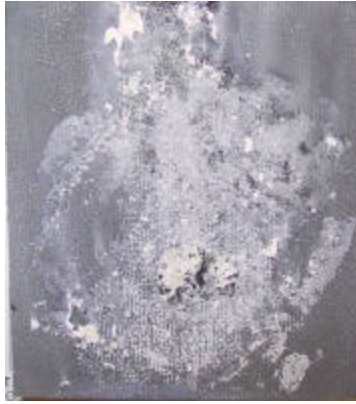
-cure

Controlled Sample

Vacuum Cured/ 300°F for 30 min.

Vacuum Cured/ 7 days  
Hot Cycle

Vacuum Cured/ 2 days  
Hot Cycle

Vacuum Cured/ 7 days  
Cold Cycle

Vacuum Cured/ 2 days  
Cold Cycle

Cold case: -60° F – 105° F

Hot case: 65° F – 235° F

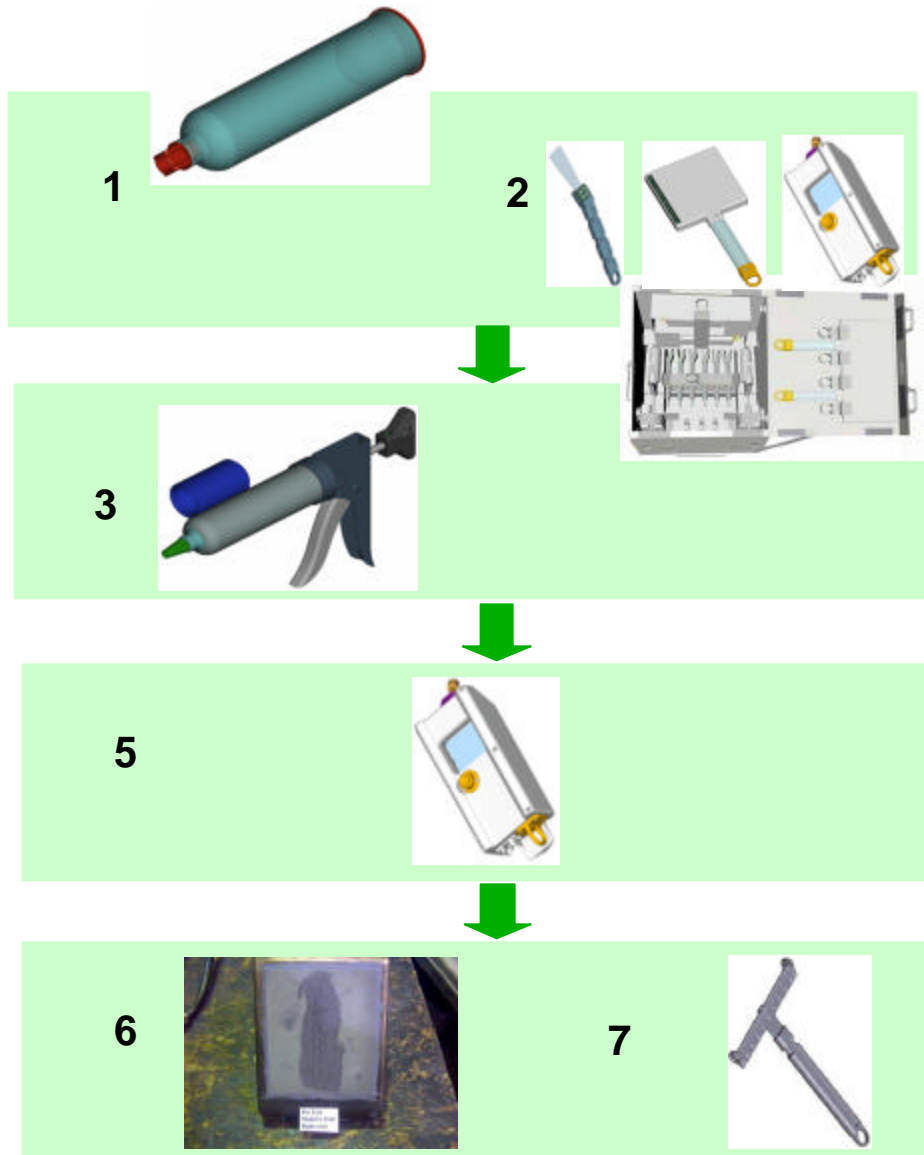
# Crack Repair Operations Concept (Contingency Repair)

- Retrieve NOAX cartridges and let thaw
- Retrieve Crack repair EVA tools and transfer bag
- Assemble Crack repair kit
  - Assemble NOAX cartridges with manual gun
  - Stow EVA tools and manual gun assemblies in transfer bag
- Translate to repair site
- Measure RCC temperature
- Apply NOAX at discrepant location
- Verify final repair protuberance

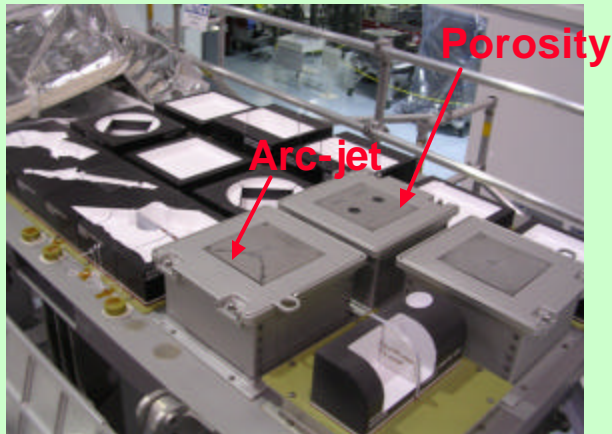
### STS-114 DTO

- IVA demonstration of Plug cover plate installation
- DTO objectives focus on Crack repair
  - One material porosity plate
  - One arc-jet test plate

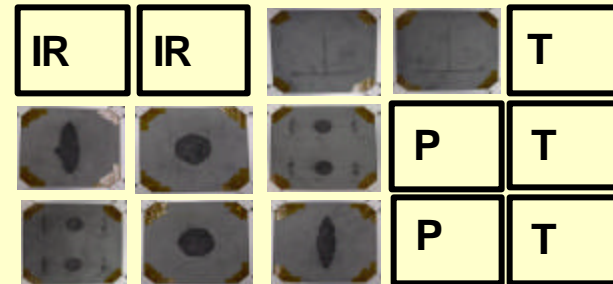
### STS-121 DTO

- DTO objectives focus on both Crack and Plug repairs
  - Two Plug repair plates (Full scale)
    - 1.1" diameter hole
    - 4" diameter hole
  - Eight Crack repair plates
    - Material porosity
    - Realistic impact damage
    - Offset crack of 0.065"

IR – Infrared Camera; P – Plug; T – Tile

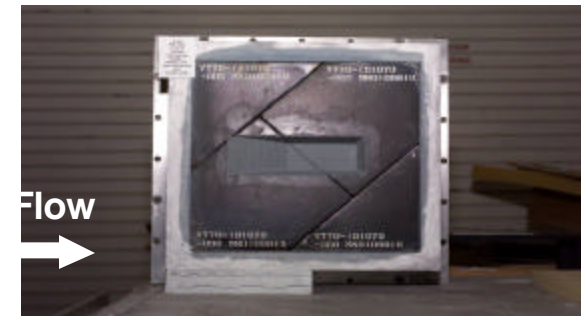
**EW Repair Arc Jet Test  
Dec 2004**

**Pre-Test**

- Material qualification completed in early April 2005
- 3 EW applicators delivered in late April
  - Applicators will be refilled with fresh material for the July launch window
- EW Repair analytical tools based on use-as-is damage assessment tools
  - Emittance and catalytic factor change to thermal tool
- EW repair thermal performance testing will be limited before RTF
  - Early (puck level) material testing performance demonstrated improved thermal performance over bare substrate for shallow damage
  - December 2004 test with 1.5" deep damage under high shear and high temperature conditions exceeded backface temperature at 1100 seconds
  - One additional EW repair on a tile array is planned to be tested in the JSC Arc-jet facility prior to RTF

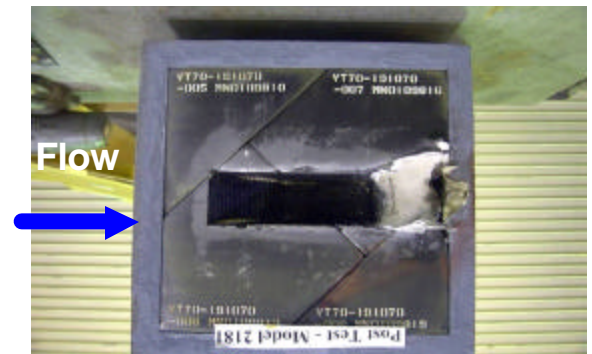
**Post-Test**

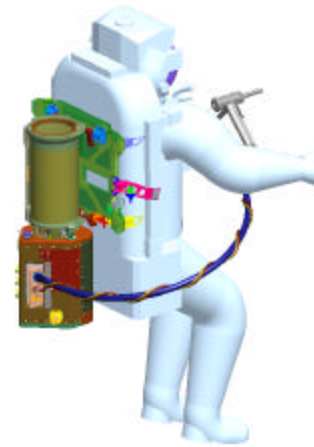
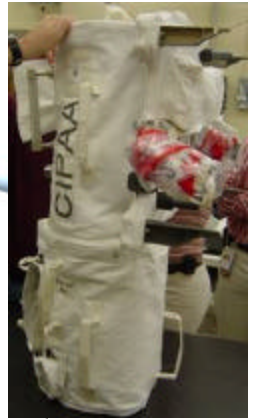
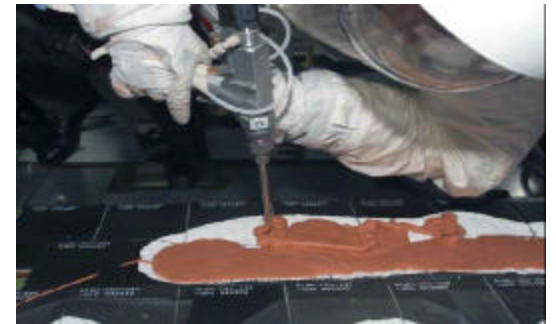
## Cure-in-Place Ablator Repair

- STA-54\* is the Cure-in-Place Ablator (CIPA) material
  - Two-part mixture: Part A base material + fillers, Part B catalyst
  - Material ratio 12 parts A to 1 part B
- CIPA Applicator
  - Pneumatic system drives individual components through a static mixer at the inlet of the dispenser gun
  - Two CIPA Applicators manifested on STS-114
  - Each applicator dispenses up to 600 cu in of material
- Tile Repair Kit Hand Tools
  - Including: Gel brushes for cleaning damaged tile surface, trash bags and material discard containers, foam brushes and stamps, contour gage, and durometer
- Repair Description
  - Damaged surface cleaned and primed (with EW)
  - STA-54 dispensed into damaged cavity to desired underfill level
  - Surface underfill measured
  - Cure of material verified during a harness test on a subsequent EVA

**\*Shuttle Tile Ablator**

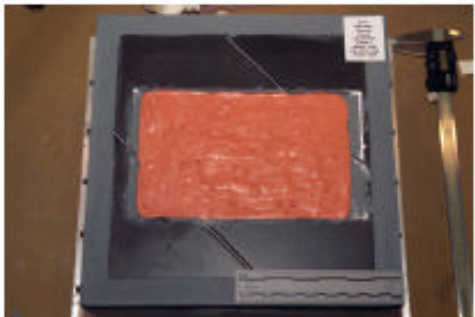
**HTV Repair**  
~0.25" underfill

- Arc-jet testing shows ablator provides thermal protection
    - Four single tile damaged arc jet tests (wedge specimens) in Jan 2005
    - Four tile arrays tested including one article repaired in HTV (Dec 2004, Jan 2005)

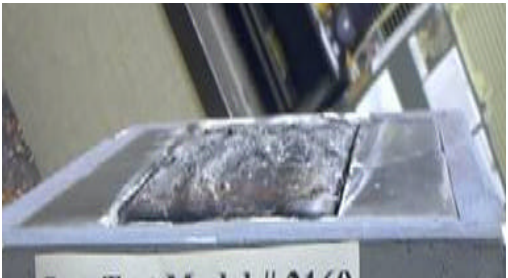
**Post Arc Jet**  
~0.25" swell above tile OML

- ***Repaired tile kept backface temperature cooler than undamaged tile***

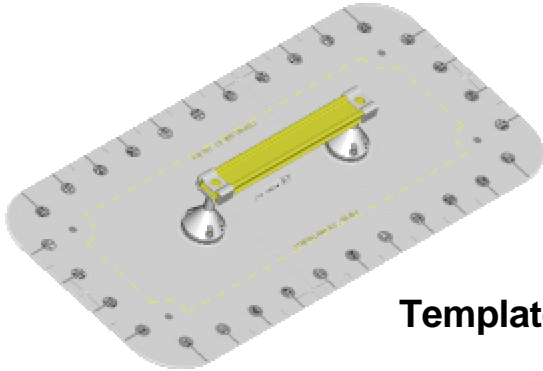
Template

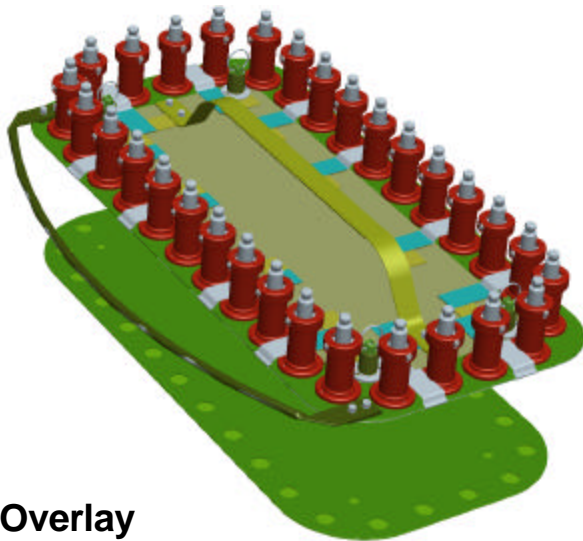
Overlay

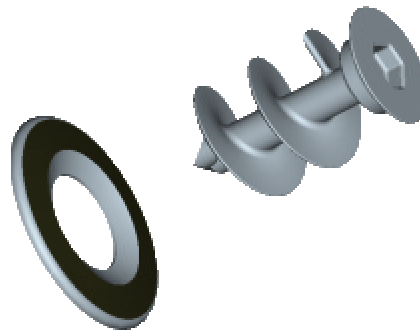
Auger Bolt/Washer

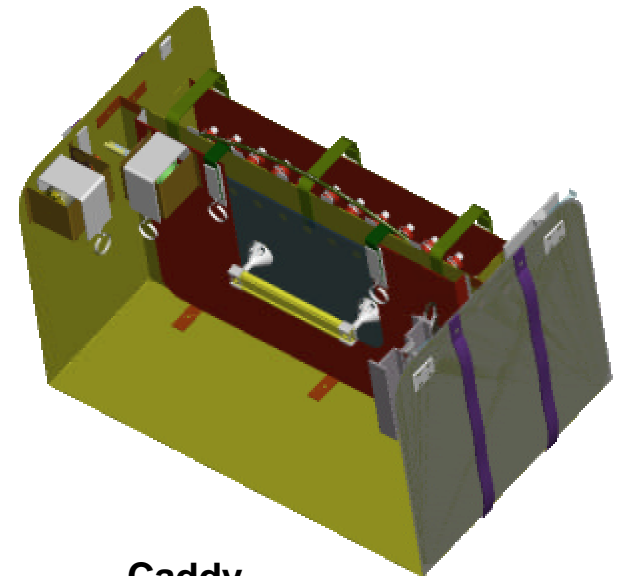
Caddy

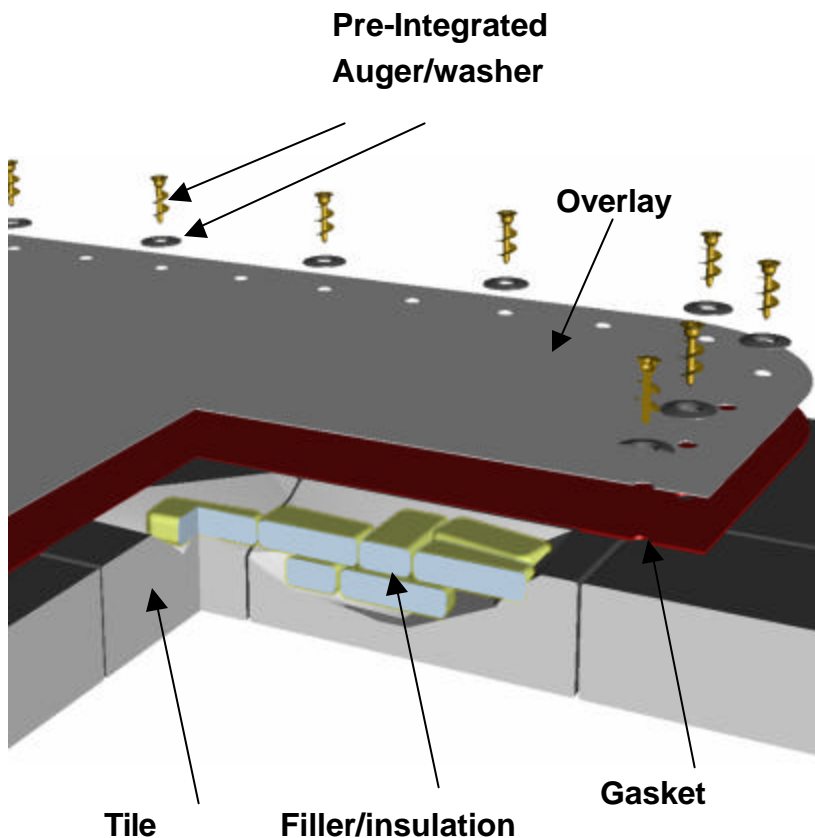
## Components of the Overlay Tile Repair

- Damaged cavity filled with Safil batting insulation
- Thin C-SiC cover plate and high temperature gasket seal placed over damaged tile
- SiC coated ceramic augers (with SiC coated ceramic washers) attached to undamaged tile
- Capability
  - 1 kit on STS-114 for contingency repair
  - 12"x25" overlay is capable of covering 10"x20" damage
  - Vibration and structural testing conducted in April and June
  - Development Arc-jet testing completed in January
  - Additional Arc-jet testing in June
  - Preliminary (uncorrelated) math models are available to predict repair performance

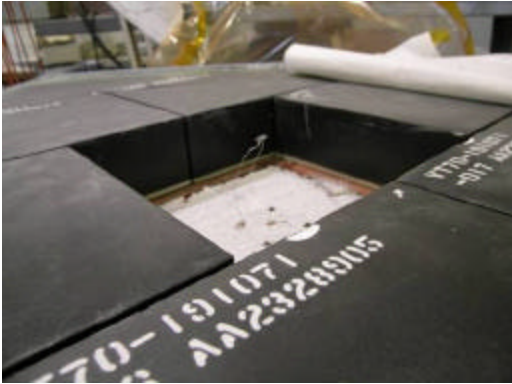
Missing Tile Damage

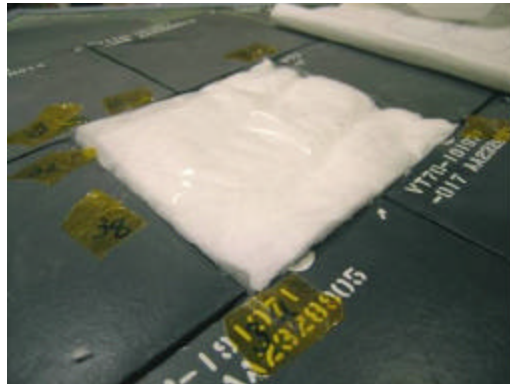
Radiant Heat Protection

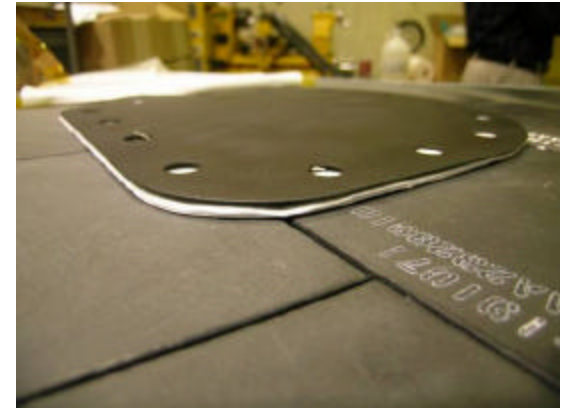
Overlay over Damage

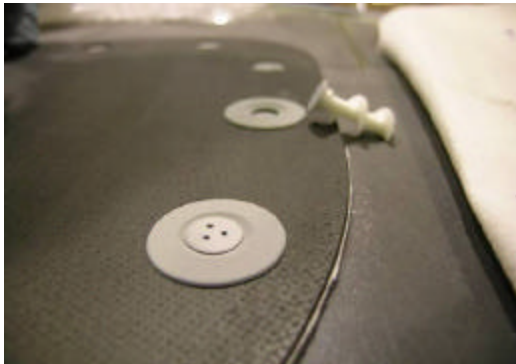
Auger Installation

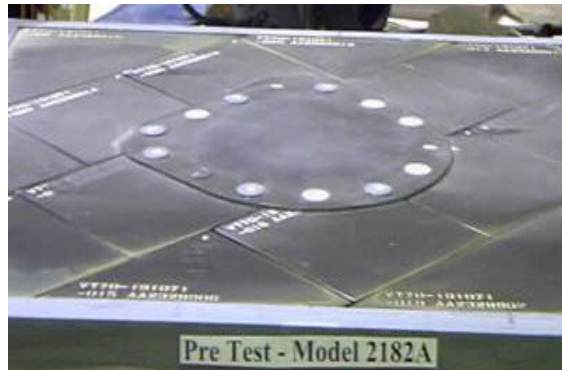
Pre Arc-Jet

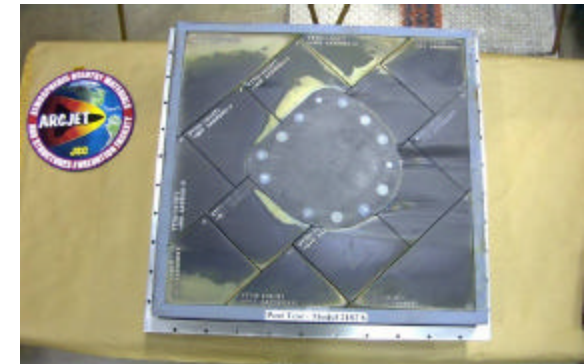
Post Arc-Jet

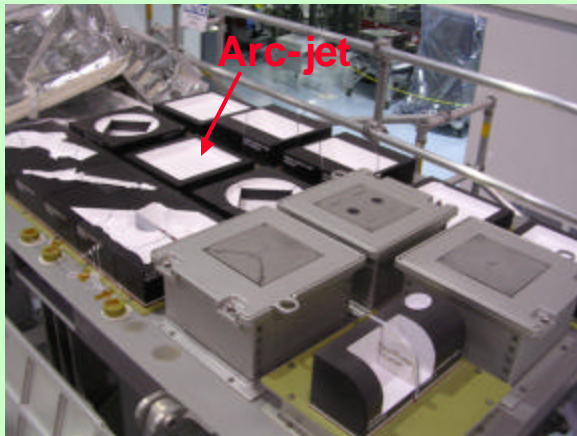
### STS-114 DTO

- DTO objectives focus on Emittance Wash repair
  - Arc-jet test samples
